AFRL-ML-WP-TR-1999-4009

EXPLORATORY NONDESTRUCTIVE EVALUATION (NDE) RESEARCH FOR ADVANCED MATERIALS AND PROCESSES

VOLUME 1 : HIGH RESOLUTION COMPUTED TOMOGRAPHY FOR FAILURE ANALYSIS

BOEING INFORMATION SPACE & DEFENSE SYSTEMS P.O.BOX 3999 SEATTLE, WA 98124

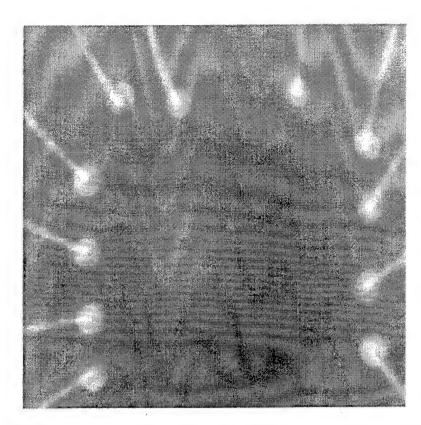
Figure 2-3. Radioscopic image of an integrated circuit showing 0.025 mm diameter gold wires bonded to the chip

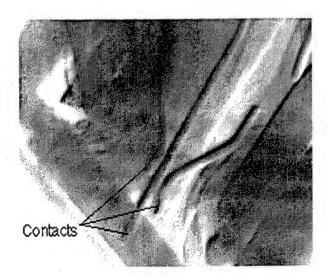
Problems with electrical relays are a common category of failure analysis investigations which take advantage of radioscopic imaging to show the condition of the relay in real-time. The relay can be mounted in the X-ray chamber and observed while it functions. This has proved extremely valuable for diagnosing problems in relays, particularly intermittent problems. Prior to the availability of the radioscopic system, the relay cans would be opened and then functioned. This, however, presented a number of concerns about the changes in the operating environment resulting from opening the cans. With radioscopy the relays' internal performance is observed completely nondestructively. Studies on relays using the microfocus radioscopy system have saved numerous hours of alternative testing and resulted in rapid analysis of problems. A common result is to find internal items, which block the functioning of the relay. If the relay is opened, there is a high risk that the blocking material will move or be lost prior to solving the problem. Figure 3.1 shows an example of a radioscopic image of a relay. The approximately 0.1 mm thick contacts are readily detected. One particularly useful technique to detect whether or not the contacts touch is to cycle the switch and to store images of the contacts open and closed. By subtracting the two images the slightest change in the stationary contact will be detected which indicates that a mechanical contact has been made.

Figure 3.1. Edge enhanced radioscopic image of relay

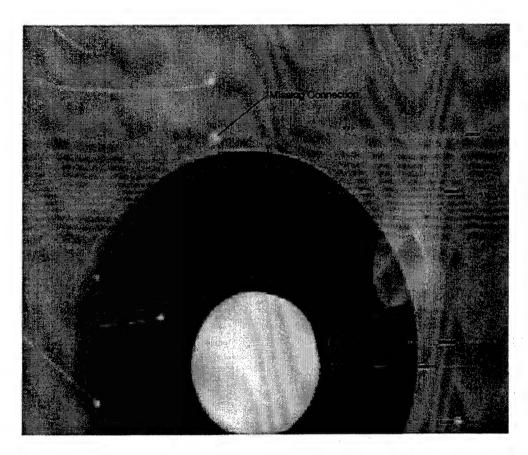
Another example shows the use of very high magnification to identify a missing wire in a solid state relay. Figure 3.2 shows the radioscopic image with the missing wire bond identified.

Figure 3.2. Solid state relay with a missing wire

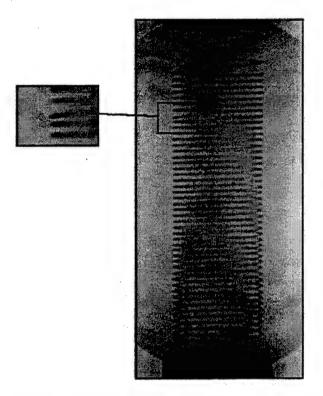
Figure 3.3. Radioscopic image of a wire wound resistor (approximately 1 mm diameter coil) showing improper spacing

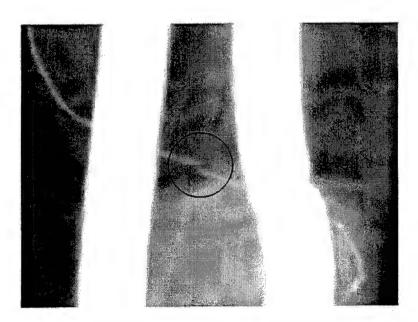
Figure 3.5. Radioscopic image of a temperature sensor showing a broken wire

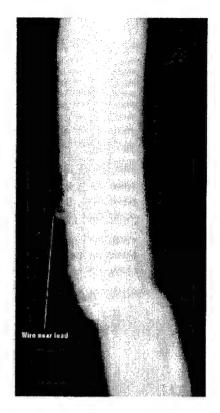
Sometimes, however, the location of a failure is such that the radioscopic image cannot detect the problem. Figure 3.6 shows a radioscopic image of a different temperature sensor which had failed. The wire is shown adjacent to a lead. The interpretation of the connection of the wire to the lead cannot be made from this radioscopic view alone. In this view, the wire appears to contact the lead, however, the sensor performance indicates that no signal is available. A series of CT slices is taken of the wire/lead connection location. Figure 3.7 shows the CT image sequence where the wire approaches the lead, but does not actually connect to it. From these data the interpretation of a failed wire to lead bond connection can be made.

Figure 3.6. Radioscopic image of a temperature sensor showing a wire near a lead

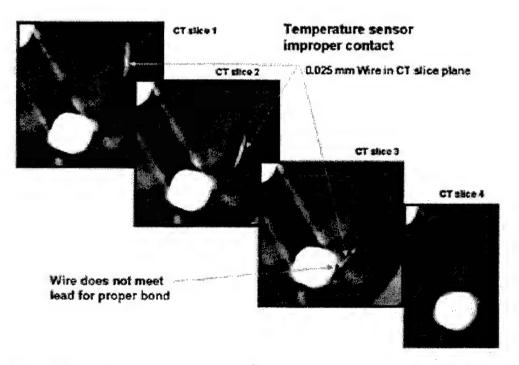
Figure 3.7. CT contiguous image sequence showing the temperature sensor wire failed to connect to the lead

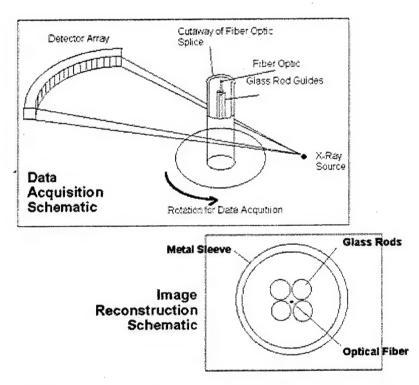
Figure 3.8. Configuration of high resolution CT to evaluate a fiber optic connection

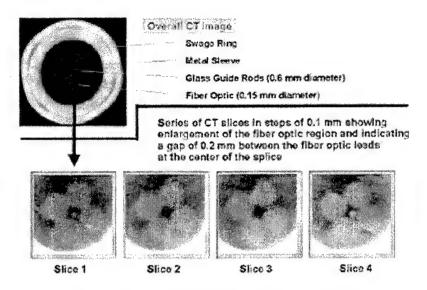
Figure 3.9 shows an example CT evaluation of the fiber optic splice. The upper left image shows the full CT slice of the connector with the metal sleeve and a swage ring. Below is a series of CT slices zoomed in to reconstruct only the glass rods and the fiber optic. The fiber optic is located between the four glass rods in slice 1 and slice 4, but is missing in slices 2 and 3. This gap where the two fibers should come together, explains the poor performance of this connection.

Figure 3.9. CT data from a fiber optic splice

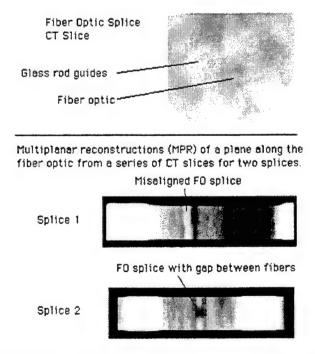
In order to evaluate the internal configuration, the series of contiguous CT slices can be reconfigured. The series of slices form a three-dimensional data set which can be viewed from any orientation. This is called multiplanar reconstruction (MPR). Figure 3.10 shows this type of data. The top image is an axial slice through the splice. The bottom two images are MPR images. These reconstructions view the fiber along its length to show the fiber condition at the splice point, where two fibers should come together and touch. One image shows a misalignment of the two fibers and the other shows that they do not touch (the data of Figure 3.9). Such measurements are not possible by any other means.

Figure 3.10. CT data from a fiber optic splice showing MPR views of two bad splices

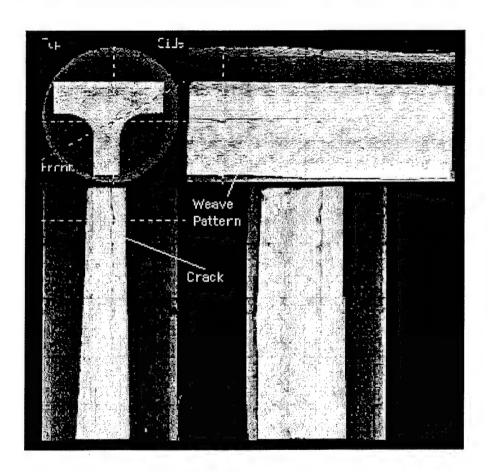
Samples that are normally evaluated for micrographic analysis can often benefit from nondestructive CT analysis. Figure 3.11 shows the results of a CT evaluation for a resin transfer molded composite T sample. CT data were taken for 127 contiguous slices each 0.25 mm thick with a 19 mm field of view. Using multiplanar reconstruction, the CT slices are combined into a volumetric model of the part and then viewed in orthogonal slices through the volume data set. In the upper left corner of the Figure 3.11 data is the standard CT slice (#17 of the 127). The upper right and lower left are side and front views through the data set. An oblique view is shown in the lower right; its orientation is given by the angled dotted line on the upper left CT image. The Figure 3.11 data show a crack in the radius of the sample and how the crack propagates around the woven composite structure.

Figure 3.11. CT data from a composite sample

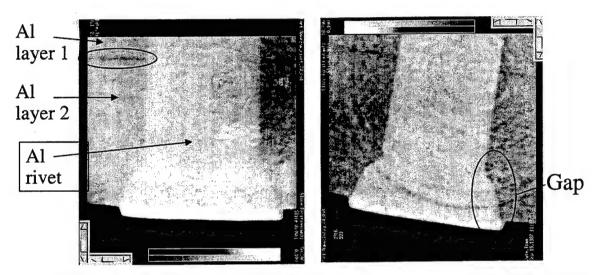
Rivets in aircraft structures have been traditionally evaluated using micrographic studies (13). The rivet is sectioned and evaluated for fit up as a function of processing parameters. CT scanning of the rivet as shown in Figure 3.12 shows that the pre and post sectioning condition of the rivet changes due to stress relief. In Figure 3.12 the presectioning image shows no significant gap between the rivet and the aluminum layer. A gap is detected between the two aluminum layers. In the post sectioned image of a rivet, taken just below

the cut surface, a gap is shown in the CT image between the rivet and the aluminum layer around the rivet head. Photomicrographs of the cut specimen noted 0.050 mm (0.002 inch) wide gaps. The CT post sectioned scan indicated 0.050 to 0.075 mm (0.002 to 003 inch) gaps at this location indicating that the gaps are a result of sectioning. These results clearly indicate that using the micrography data on a sectioned rivet to establish the condition present prior to sectioning is not correct. Rather, nondestructive evaluation can produce a more accurate description of the true part condition. Although the micrographic images have greater resolution than the CT data, the data are not a valid representation of the as-riveted condition. Sectioning relieves stresses resulting in a change in the true geometry of a structure.

a) Pre sectioning CT image showing no gaps b) Post sectioning image shows gaps

Figure 3.12. CT scan of rivet a) pre sectioning and b) post sectioning

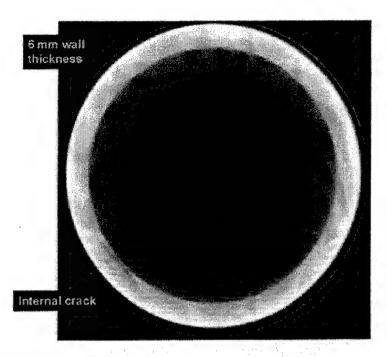
Another example of the use of high resolution CT on metallic structure is one that the benefits of CT prior to the test were thought to be dubious at best. This example is a small pressure reservoir that was leaking, but the leak could not be detected by other than a leak test. CT was used and a crack detected as shown in Figure 3.13. A series of CT slices was taken and displayed in MPR to show the orientation of the crack in the reservoir wall.

Figure 3.13. CT slice through the reservoir showing the crack

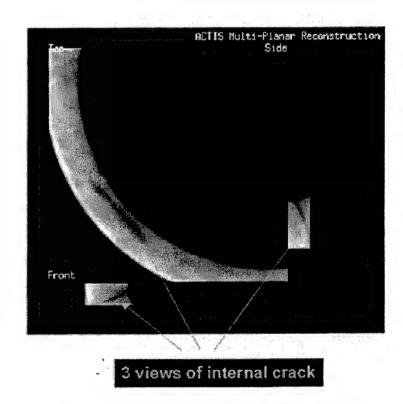
Figure 3.14. MPR of the crack in the reservoir
